**Flood Control Project Maintenance  
Levee Inspections**

## Maintenance Issue Types Only, Levee Inspection Report By Mile - Spring 2019

### Sutter Maintenance Yard Maintenance Area 0001

Waterway	Bank	Unit Miles	Inspection Start/End	Inspector
Unit No. 01 Sacramento River	Right	16.76	04/17/2019 04/17/2019	Makar Sokol

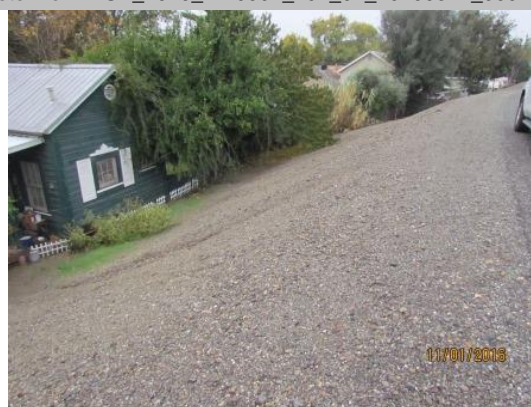
Photo 1 of 1 : SP\_2019\_MA0001\_297\_94\_20190327\_00028.jpg

LM Start	<b>0.09</b>	Rating **	A/W	Issue No.	<b>94</b>
LM End	<b>0.09</b>	Issue Type +	Ma	Location *	LS
Category	Earthen Levee		GPS Latitude/Longitude		
			Start	End	
Item	Slope Stability		39.214217 °	39.214217 °	
			-122.002378 °	-122.002378 °	
DWR ID	DWR_MA0001_01_f_2016_94				
Comment Code					
S2 : Repair the levee slope damaged by foot traffic and prevent access where possible.					
Inspector Comment

View of the slope instability along the landside slope.

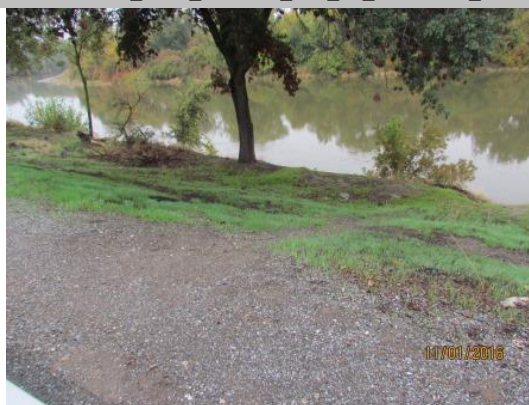
Photo 1 of 1 : SP\_2019\_MA0001\_297\_98\_20190327\_00029.jpg

LM Start	0.38	Rating **	A/W	Issue No.	98
LM End	0.38	Issue Type +	Ma	Location *	WS
Category	Earthen Levee			GPS Latitude/Longitude	
				Start	End
Item	Slope Stability			39.215878 °	39.215878 °
				-122.007278 °	-122.007278 °
DWR ID	DWR_MA0001_01_f_2016_98				
Comment Code					
S2 : Repair the levee slope damaged by foot traffic and prevent access where possible.					
Inspector Comment

View of the slope instability along the waterside slope.

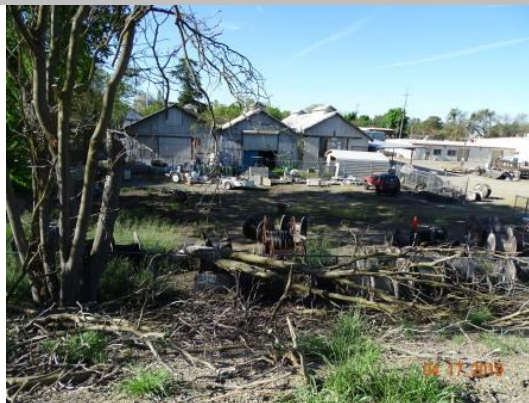
Photo 1 of 1 : SP\_2019\_MA0001\_297\_79\_20190418\_00150.jpg

View of the tree branches and limbs at the landside toe. Spring 2019.

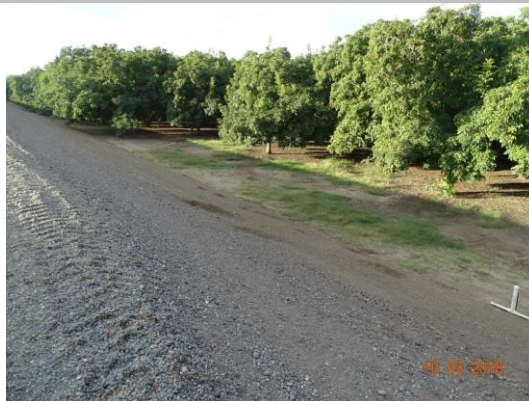
Photo 1 of 1 : SP\_2019\_MA0001\_297\_68\_20190327\_00015.jpg

View of the rodent holes along the landside slope.

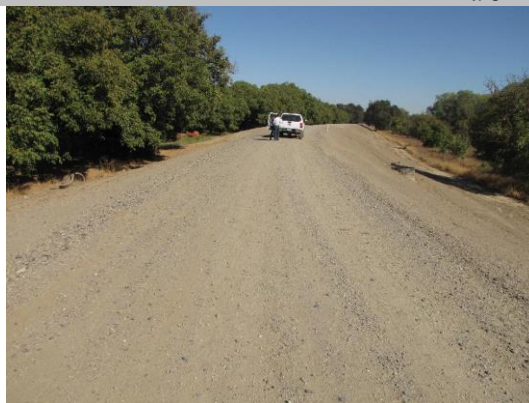
Photo 1 of 3 : UCIP\_SP\_2019\_51852\_70064.jpg

Comment Code						
Inspector Comment						
FS_ID:51852 DS_ID:16430 EP_NO: 9487 Repair Type: Non-Urgent Crossing Status: Found UCIP Comments: 5/3/2017 WS end still partially plugged. (DWR Sutter Yard- A Freitag)10/24/2016 Ws end is till partially plugged.(DWR Sutter Yard- A Freitag)4/25/2016 WS pipe end is still plugged with soil. Rest of the pipe appeared to be in good condition.4/20/2015 WS pipe end is plugged about 50% by soil.6/18/2014 Same as last inspection.12/17/2013 Same as last inspection.7/18/2013 WS pipe end has been reformed but is still clogged about 50% by sediment.10/18/2012 Remove dirt and debris in riser. Outlet deformed and blocked over 50%. Debris-round concrete section on landward side. This crossing was listed in the USACE Periodic Inspections as ID# USACE_CESPK_MA1C_2010_p_0116 for crossing outlet deformed and clogged with dirt. FIELD_STRUCT_DESC: 1 of 2: 36-inch corrugated metal drainage pipe through the levee, approximately 12-15 feet below the crown. Slide gates in corrugated metal pipe (CMP) riser located on the waterside (WS) slope. Pipe daylights on the landside (LS). (36-inch pipe [HLM 1.97] authorized under Automatic Board Order (ABO) issued as Permit No. 9487, 1974 - Jimeno Rancho) [Additional Reference(s): DWR Levee Log, 1992. USACE Sacramento O&M Manual 137, August 1955, (Station 103+18)]. FS Date: 5/19/2017 1:20:29 PM

Overview of levee crown and slopes looking upstream towards crossing.

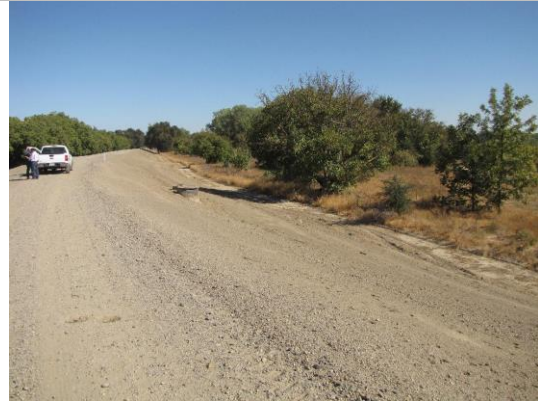
Photo 2 of 3 : UCIP\_SP\_2019\_51852\_70063.jpg

FS\_ID:51852  
DS\_ID:16430  
EP\_NO: 9487  
Repair Type: Non-Urgent  
Crossing Status: Found  
UCIP Comments: 5/3/2017 WS end still partially plugged. (DWR Sutter Yard- A Freitag)10/24/2016 WS end is still partially plugged.(DWR Sutter Yard- A Freitag)4/25/2016 WS pipe end is still plugged with soil. Rest of the pipe appeared to be in good condition.4/20/2015 WS pipe end is plugged about 50% by soil.6/18/2014 Same as last inspection.12/17/2013 Same as last inspection.7/18/2013 WS pipe end has been reformed but is still clogged about 50% by sediment.10/18/2012 Remove dirt and debris in riser. Outlet deformed and blocked over 50%. Debris-round concrete section on landward side. This crossing was listed in the USACE Periodic Inspections as ID# USACE\_CESPK\_MA1C\_2010\_p\_0116 for crossing outlet deformed and clogged with dirt.  
FIELD\_STRUCT\_DESC: 1 of 2: 36-inch corrugated metal drainage pipe through the levee, approximately 12-15 feet below the crown. Slide gates in corrugated metal pipe (CMP) riser located on the waterside (WS) slope. Pipe daylights on the landside (LS). (36-inch pipe [HLM 1.97] authorized under Automatic Board Order (ABO) issued as Permit No. 9487, 1974 - Jimeno Rancho) [Additional Reference(s): DWR Levee Log, 1992. USACE Sacramento O&M Manual 137, August 1955, (Station 103+18)].

View of WS looking upstream at CMP riser on slope.

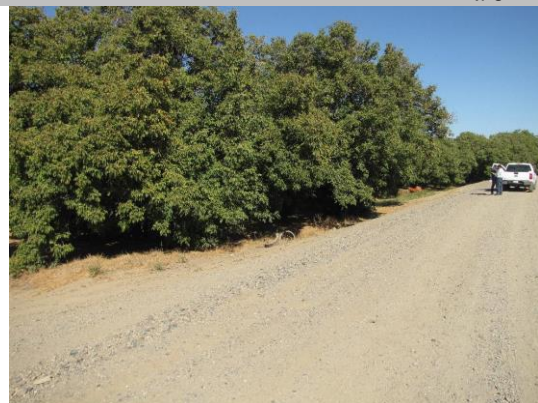
Photo 3 of 3 : UCIP\_SP\_2019\_51852\_70062.jpg

View of LS looking upstream at crossing.

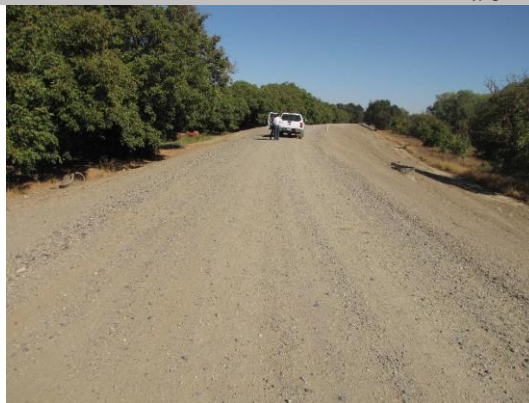
Photo 1 of 3 : UCIP\_SP\_2019\_51853\_70071.jpg

FS\_ID:51853  
DS\_ID:17565  
EP\_NO: 9487  
Repair Type: Non-Urgent  
Crossing Status: Found  
UCIP Comments: 5/3/2017 Ws end still partially plugged. (DWR Sutter Yard- A Freitag)10/24/2016 Ws pipe end still plugged.(DWR Sutter Yard- A Freitag)4/25/2016 WS pipe end still plugged with soil. rest of pipe appears in good condition.4/20/2015 WS pipe end plugged about 50% by soil.6/18/2014 Same as last inspection.12/17/2013 Same as last inspection.7/18/2013 WS pipe end has been reformed but is still partially blocked with dirt and debris.10/18/2012 WS-remove dirt and debris in riser. Outlet deformed and blocked over 50%. Burrow activity near outlet on waterward slope. Debris around concrete section on landward side. This crossing was listed in the USACE Periodic Inspections as ID# USACE\_CESPK\_MA1C\_2010\_p\_0116 for crossing outlet deformed and clogged with dirt.  
FIELD\_STRUCT\_DESC: 2 of 2: 36-inch corrugated metal drainage pipe through the levee, approximately 12-15 feet below the crown. Slide gates in corrugated metal pipe (CMP) riser on the waterside (WS) slope. Pipe daylights on the landside (LS). (36-inch pipe [HLM 1.97] authorized under Automatic Board Order (ABO) issued as Permit No. 9487, 1974 - Jimeno Rancho) [Additional Reference(s): DWR Levee Log, 1992. USACE Sacramento O&M Manual 137, August 1955, (Station 103+18)].

View of levee crown and slopes looking upstream at crossing.

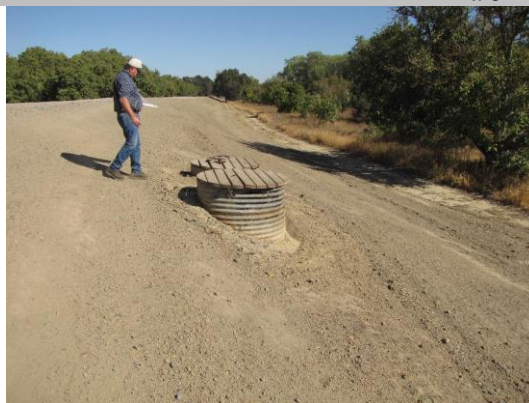
Photo 2 of 3 : UCIP\_SP\_2019\_51853\_70074.jpg

View of CMP risers located on WS slope.

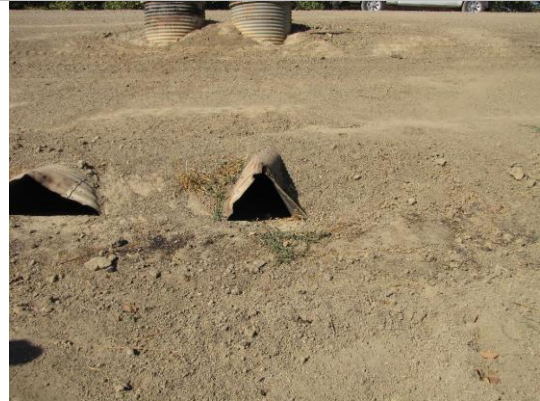
Photo 3 of 3 : UCIP\_SP\_2019\_51853\_70073.jpg

Comment Code						
Inspector Comment						
FS_ID:51853 DS_ID:17565 EP_NO: 9487 Repair Type: Non-Urgent Crossing Status: Found UCIP Comments: 5/3/2017 Ws end still partially plugged. (DWR Sutter Yard- A Freitag)10/24/2016 Ws pipe end still plugged.(DWR Sutter Yard- A Freitag)4/25/2016 WS pipe end still plugged with soil. rest of pipe appears in good condition.4/20/2015 WS pipe end plugged about 50% by soil.6/18/2014 Same as last inspection.12/17/2013 Same as last inspection.7/18/2013 WS pipe end has been reformed but is still partially blocked with dirt and debris.10/18/2012 WS-remove dirt and debris in riser. Outlet deformed and blocked over 50%. Burrow activity near outlet on waterward slope. Debris around concrete section on landward side. This crossing was listed in the USACE Periodic Inspections as ID# USACE_CESPK_MA1C_2010_p_0116 for crossing outlet deformed and clogged with dirt. FIELD_STRUCT_DESC: 2 of 2: 36-inch corrugated metal drainage pipe through the levee, approximately 12-15 feet below the crown. Slide gates in corrugated metal pipe (CMP) riser on the waterside (WS) slope. Pipe daylights on the landside (LS). (36-inch pipe [HLM 1.97] authorized under Automatic Board Order (ABO) issued as Permit No. 9487, 1974 - Jimeno Rancho) [Additional Reference(s): DWR Levee Log, 1992. USACE Sacramento O&M Manual 137, August 1955, (Station 103+18)]. FS Date: 5/19/2017 1:21:31 PM

CMP pipe outlet deformed with over 50 percent blockage.

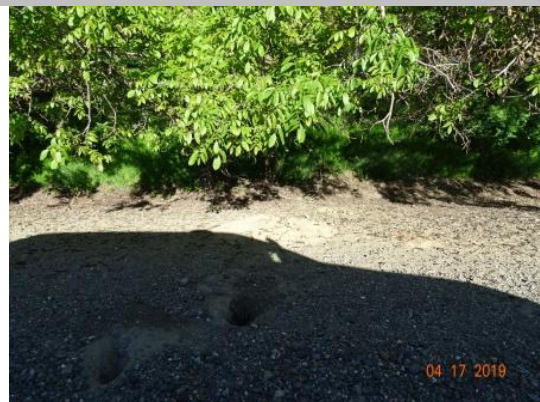
Photo 1 of 1 : SP\_2019\_MA0001\_297\_83\_20190418\_00151.jpg

LM Start	2.11	Rating **	M	Issue No.	83
LM End	2.11	Issue Type +	Ma	Location *	LS
Category	Earthen Levee			GPS Latitude/Longitude	
				Start	End
Item	Animal Control			39.234366 °	39.234366 °
				-122.014049 °	-122.014049 °
DWR ID	DWR_MA0001_01_s_2019_83				
Comment Code					
A3 : No rodents visible, but rodent burrows visible; need to backfill and compact or grout burrows.					
Inspector Comment

View of the rodent holes on the landside slope. Spring 2019.

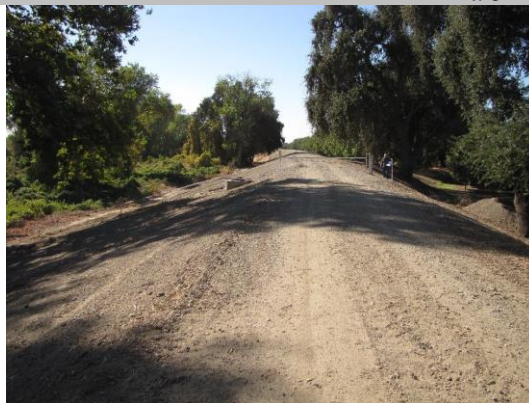
Photo 1 of 3 : UCIP\_SP\_2019\_51854\_70078.jpg

Comment Code					
Inspector Comment					
FS_ID:51854 DS_ID:16429 EP_NO: 9472 Repair Type: Non-Urgent Crossing Status: Found UCIP Comments: 5/3/2017 LS inlet partially plugged with soil. Some debris still present inside riser. (DWR Sutter Yard-AFreitag)10/24/2016 Debris still inside of riser.(DWR Sutter Yard-AFreitag)4/25/2016 Pipe still inside of riser and LS end plugged about 50% by soil.4/20/2015 Same as last inspection.6/18/2014 Same as last inspection.12/17/2013 Same as last inspection.7/18/2013 Same as last inspection.10/18/12 Remove debris from riser. Landward inlet is blocked by over 50%. This crossing was listed in the USACE Periodic Inspections as ID# USACE_CESPK_MA1C_2010_p_0128 for sediment build up at inlet (landward side) and debris inside riser. FIELD_STRUCT_DESC: 54-inch corrugated metal drainage pipe through the levee, approximately 12-15 feet below the crown. Slide gate in corrugated metal pipe (CMP) riser on the waterside (WS) slope. 48-inch CMP at landside (LS) slope. This crossing crosses the levee at an angle. (54-inch pipe [HLM 2.29] authorized under Automatic Board Order (ABO) issued as Permit No. 9472, 1974 - Ballard) ) [Additional Reference(s): DWR Levee Log, 1992. USACE Sacramento O&M Manual 137, August 1955, (Station 120+00)]. FS Date: 5/19/2017 1:23:34 PM

View of levee crown looking downstream at crossing. CMP riser located on WS shoulder.

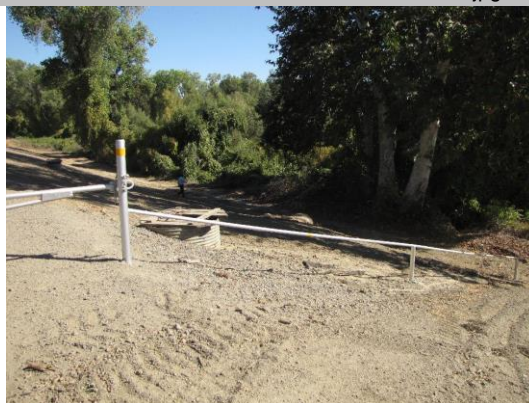
Photo 2 of 3 : UCIP\_SP\_2019\_51854\_70079.jpg

View of WS looking at slope and channel.

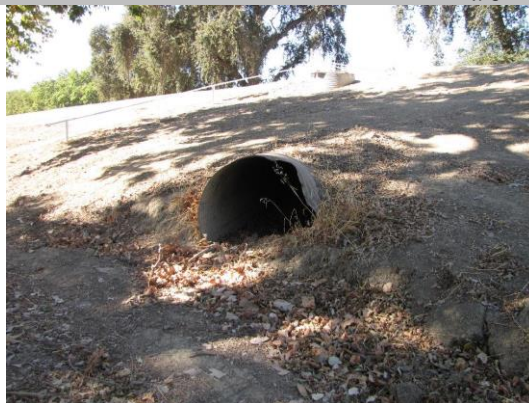
Photo 3 of 3 : UCIP\_SP\_2019\_51854\_70077.jpg

Comment Code						
Inspector Comment						
FS_ID:51854 DS_ID:16429 EP_NO: 9472 Repair Type: Non-Urgent Crossing Status: Found UCIP Comments: 5/3/2017 LS inlet partially plugged with soil. Some debris still present inside riser. (DWR Sutter Yard-AFreitag)10/24/2016 Debris still inside of riser.(DWR Sutter Yard-AFreitag)4/25/2016 Pipe still inside of riser and LS end plugged about 50% by soil.4/20/2015 Same as last inspection.6/18/2014 Same as last inspection.12/17/2013 Same as last inspection.7/18/2013 Same as last inspection.10/18/12 Remove debris from riser. Landward inlet is blocked by over 50%. This crossing was listed in the USACE Periodic Inspections as ID# USACE_CESPK_MA1C_2010_p_0128 for sediment build up at inlet (landward side) and debris inside riser. FIELD_STRUCT_DESC: 54-inch corrugated metal drainage pipe through the levee, approximately 12-15 feet below the crown. Slide gate in corrugated metal pipe (CMP) riser on the waterside (WS) slope. 48-inch CMP at landside (LS) slope. This crossing crosses the levee at an angle. (54-inch pipe [HLM 2.29] authorized under Automatic Board Order (ABO) issued as Permit No. 9472, 1974 - Ballard) ) [Additional Reference(s): DWR Levee Log, 1992. USACE Sacramento O&M Manual 137, August 1955, (Station 120+00)]. FS Date: 5/19/2017 1:23:34 PM

View of outlet located at WS toe.

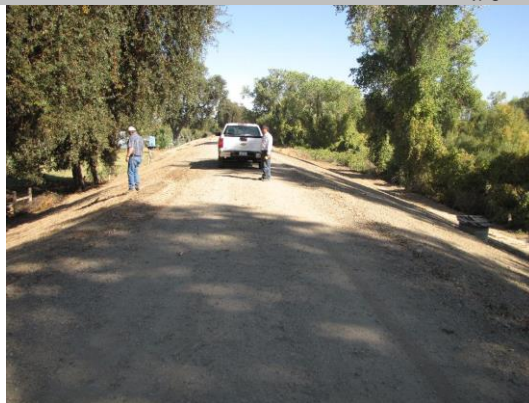
Photo 1 of 3 : UCIP\_SP\_2019\_51855\_70085.jpg

Comment Code						
Inspector Comment						
FS_ID:51855 DS_ID:16428 EP_NO: 9467 Repair Type: Non-Urgent Crossing Status: Found UCIP Comments: 5/3/2017 Abanoned- needs to be done so properly. (DWR Sutter Yard- A Freitag)10/24/2016 Abandoned.(DWR Sutter Yard- A Freitag)4/25/2016 Abandoned crossing. Unable to locate any WS and LS pipe ends.4/20/2015 Same as last inspection.6/18/2014 Same as last inspection.12/17/2013 Same as last inspection.7/18/2013 Same as last inspection.10/18/2012 Only riser visible. Debris and sediment blocking gate. Gate inside riser is buried and non-functional. If crossing is abandoned, owner needs to properly abandon. This crossing was listed in the USACE Periodic Inspections as ID# USACE_CESPK_MA1C_2010_p_0132 no culvert through the levee is visible here. FIELD_STRUCT_DESC: *ABANDONED* 24-inch corrugated metal drainage pipe through the levee, approximately 12-15 feet below the crown. Slide gate in CM pipe riser on the waterside (WS) slope. No signs of inlet visible on the landside (LS). (24-inch pipe [HLM 2.31] authorized under Automatic Board Order (ABO) issued as Permit No. 9467, 1974 - Lovell E. Spurgeon) [Additional Reference(s): DWR Levee Log, 1992. USACE Sacramento O&M Manual 137, August 1955, (Station 120+60)]. FS Date: 5/19/2017 1:48:04 PM

Overview of levee crown looking upstream at crossing.

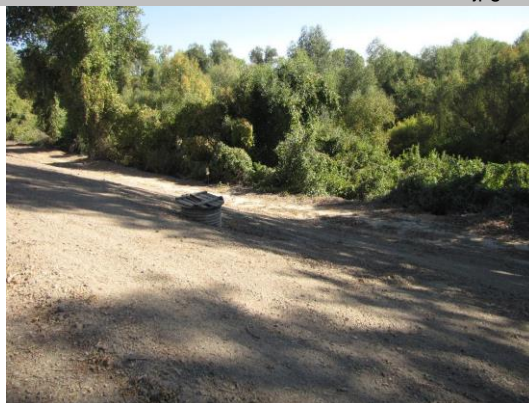
Photo 2 of 3 : UCIP\_SP\_2019\_51855\_70084.jpg

View of WS slope and toe.

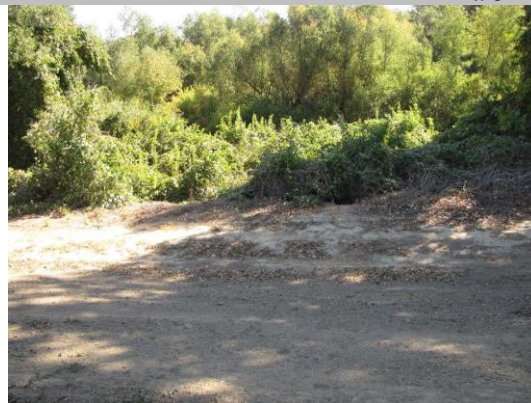
Photo 3 of 3 : UCIP\_SP\_2019\_51855\_70083.jpg

Comment Code						
Inspector Comment						
FS_ID:51855 DS_ID:16428 EP_NO: 9467 Repair Type: Non-Urgent Crossing Status: Found UCIP Comments: 5/3/2017 Abanoned- needs to be done so properly. (DWR Sutter Yard- A Freitag)10/24/2016 Abandoned.(DWR Sutter Yard- A Freitag)4/25/2016 Abandoned crossing. Unable to locate any WS and LS pipe ends.4/20/2015 Same as last inspection.6/18/2014 Same as last inspection.12/17/2013 Same as last inspection.7/18/2013 Same as last inspection.10/18/2012 Only riser visible. Debris and sediment blocking gate. Gate inside riser is buried and non-functional. If crossing is abandoned, owner needs to properly abandon. This crossing was listed in the USACE Periodic Inspections as ID# USACE_CESPK_MA1C_2010_p_0132 no culvert through the levee is visible here. FIELD_STRUCT_DESC: *ABANDONED* 24-inch corrugated metal drainage pipe through the levee, approximately 12-15 feet below the crown. Slide gate in CM pipe riser on the waterside (WS) slope. No signs of inlet visible on the landside (LS). (24-inch pipe [HLM 2.31] authorized under Automatic Board Order (ABO) issued as Permit No. 9467, 1974 - Lovell E. Spurgeon) [Additional Reference(s): DWR Levee Log, 1992. USACE Sacramento O&M Manual 137, August 1955, (Station 120+60)]. FS Date: 5/19/2017 1:48:04 PM

Unable to locate WS outlet.

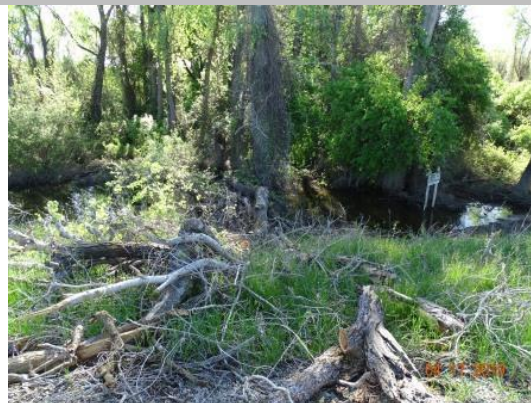
Photo 1 of 1 : SP\_2019\_MA0001\_297\_84\_20190418\_00152.jpg

LM Start	2.37	Rating **	U	Issue No.	84
LM End	2.37	Issue Type +	Ma	Location *	WS
Category	Earthen Levee			GPS Latitude/Longitude	
				Start	End
Item	Encroachments			39.237692 °	39.237692 °
				-122.011827 °	-122.011827 °
DWR ID	DWR_MA0001_01_s_2019_84				
Comment Code					
PR : Prunings					
Inspector Comment

The tree branches and limbs should be removed from the waterside slope and toe. Spring 2019.

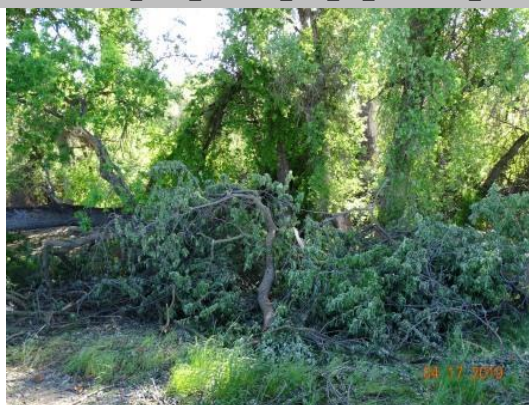
Photo 1 of 1 : SP\_2019\_MA0001\_297\_96\_20190418\_00153.jpg

View of the tree branches on the waterside slope. Spring 2019.

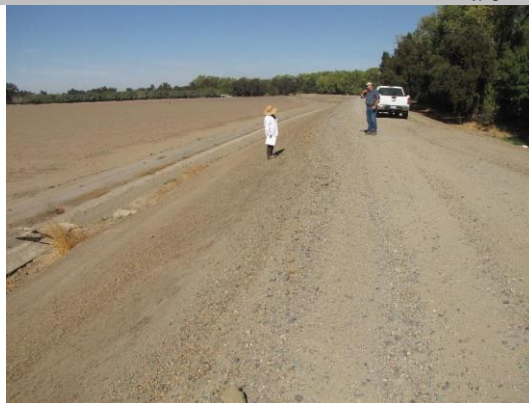
Photo 1 of 3 : UCIP\_SP\_2019\_51859\_70110.jpg

FS\_ID:51859  
DS\_ID:16426  
EP\_NO: 9490  
Repair Type: Non-Urgent  
Crossing Status: Found  
UCIP Comments: 5/3/2017 Sediment build up in WS pipe end. WS slide gate stem bent but it does not affect its operation. (DWR Sutter Yard- A Freitag) 10/24/2016 WS slide gate stem is still bent. (DWR Sutter Yard- A Freitag) 4/25/2016 WS slide gate is slightly bent. Rest of crossing appears to be in good condition. 4/20/2015 LS inlet still has some minor sediment build up. Needs to be cleaned. 6/18/2014 Same as last inspection. 12/17/2013 Same as last inspection. 7/18/2013 WS slide gate looks to be in good condition but stem is slightly bent. Not sure if bend will hinder gates operation or not. LS inlet is still blocked by minor sediment build up. 10/18/2012 LS pipe slightly deformed and sediment build up blocking about 30% of opening; need to check the condition of the slide gate-need photo. Metal marker down. This crossing was listed in the USACE Periodic Inspection as ID# USACE\_CESPK\_MA1C\_2010\_p\_0187 for sediment build up at landward toe.

View of LS looking upstream.

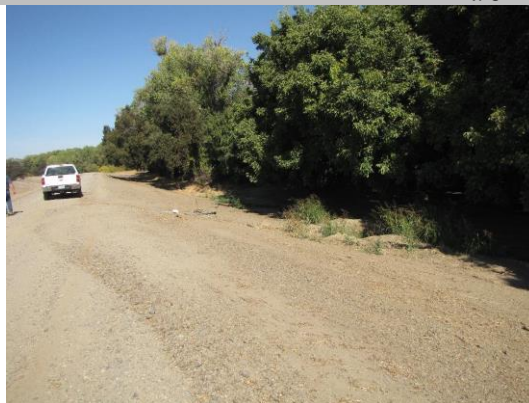
Photo 2 of 3 : UCIP\_SP\_2019\_51859\_70109.jpg

Comment Code						
Inspector Comment						
FS_ID:51859 DS_ID:16426 EP_NO: 9490 Repair Type: Non-Urgent Crossing Status: Found UCIP Comments: 5/3/2017 Sediment build up in WS pipe end. WS slide gate stem bent but it does not affect its operation. (DWR Sutter Yard- A Freitag)10/24/2016 WS slide gate stem is still bent.(DWR Sutter Yard- A Freitag)4/25/2016 WS slide gate is slightly bent. Rest of crossing appears to be in good condition. 4/20/2015 LS inlet still has some minor sediment build up. Needs to be cleaned.6/18/2014 Same as last inspection.12/17/2013 Same as last inspection.7/18/2013 WS slide gate looks to be in good condition but stem is slightly bent. Not sure if bend will hinder gates operation or not. LS inlet is still blocked by minor sediment build up.10/18/2012 LS pipe slightly deformed and sediment build up blocking about 30% of opening; need to check the condition of the slide gate-need photo. Metal marker down. This crossing was listed in the USACE Periodic Inspection as ID# USACE_CESPK_MA1C_2010_p_0187 for sediment build up at landward toe. FIELD_STRUCT_DESC: 36-inch corrugated metal drainage pipe through the levee, approximately 12-15 feet below the crown. Slide gate in corrugated metal pipe (CMP) riser on the waterside (WS) slope. (36-inch pipe [HLM 3.78] authorized under Automatic Board Order (ABO) issued as Permit No. 9490, 1955 - Charles & Virginia Yerxa) [Additional Reference(s): DWR Levee Log, 1992. USACE Sacramento O&M Manual 137, August 1955, (Station 177+67)]. FS Date: 5/19/2017 1:53:31 PM

View of WS looking upstream.

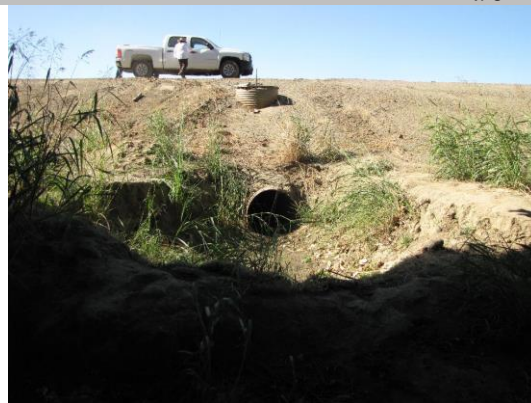
Photo 3 of 3 : UCIP\_SP\_2019\_51859\_70111.jpg

Comment Code						
Inspector Comment						
FS_ID:51859 DS_ID:16426 EP_NO: 9490 Repair Type: Non-Urgent Crossing Status: Found UCIP Comments: 5/3/2017 Sediment build up in WS pipe end. WS slide gate stem bent but it does not affect its operation. (DWR Sutter Yard- A Freitag)10/24/2016 WS slide gate stem is still bent.(DWR Sutter Yard- A Freitag)4/25/2016 WS slide gate is slightly bent. Rest of crossing appears to be in good condition. 4/20/2015 LS inlet still has some minor sediment build up. Needs to be cleaned.6/18/2014 Same as last inspection.12/17/2013 Same as last inspection.7/18/2013 WS slide gate looks to be in good condition but stem is slightly bent. Not sure if bend will hinder gates operation or not. LS inlet is still blocked by minor sediment build up.10/18/2012 LS pipe slightly deformed and sediment build up blocking about 30% of opening; need to check the condition of the slide gate-need photo. Metal marker down. This crossing was listed in the USACE Periodic Inspection as ID# USACE_CESPK_MA1C_2010_p_0187 for sediment build up at landward toe. FIELD_STRUCT_DESC: 36-inch corrugated metal drainage pipe through the levee, approximately 12-15 feet below the crown. Slide gate in corrugated metal pipe (CMP) riser on the waterside (WS) slope. (36-inch pipe [HLM 3.78] authorized under Automatic Board Order (ABO) issued as Permit No. 9490, 1955 - Charles & Virginia Yerxa) [Additional Reference(s): DWR Levee Log, 1992. USACE Sacramento O&M Manual 137, August 1955, (Station 177+67)]. FS Date: 5/19/2017 1:53:31 PM

View of WS slope, riser with slide gate, and outlet.

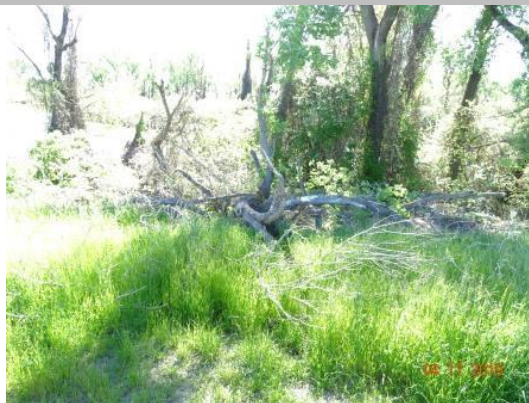
Photo 1 of 1 : SP\_2019\_MA0001\_297\_105\_20190418\_00154.jpg

View of the fallen tree on the waterside slope. Spring 2019.

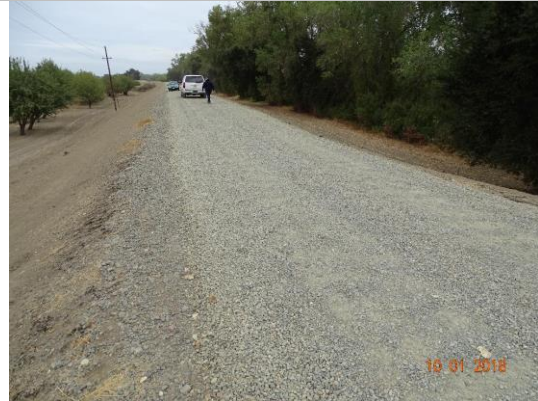
Photo 1 of 3 : UCIP\_SP\_2019\_53049\_78240.jpg

FS\_ID:53049  
DS\_ID:16446  
EP\_NO: N/A  
Repair Type: Urgent  
Crossing Status: Found  
UCIP Comments: 10/1/2018 PVC pipe underneath the slide gate that is located inside CMP riser on WS shoulder was restored and blocks gate from closing. Sediment built up at the bottom of CMP riser. PVC pipe needs to be removed in order to properly close slide gate. (O.Yakimov - DWR)5/3/2017 Pipe leaked during the Jan/Feb 2017 high water event. Sand bags were placed at both the LS and WS outlets as well as down inside the standpipe to slow the water flow. The 5inch pvc was cut away but the slide gate could still not close fully. Suspect sediment build up was in the bottom of the stand pipe was blocking the gate. Inside of pipe should be cleaned out. (DWR Sutter Yard-AFreitag)10/24/2016 Pvc was back running through the crossing and blocking the screwgate. photo attached(DWR Sutter Yard-AFreitag)9/28/2016 Crossing has been downgraded from Urgent to Non-Urgent 5-inch PVC pipe was cut to allow the slide gate to close. Need to contact owner to remove unauthorized pipe to comply with Title 23. (DWR UCIP - omagana)4/25/2016 5 inch pvc pipe running through crossing has been cut out to allow the slide gate to close. (DWR Sutter Yard - afreitag)4/20/2015 5inch pvc is still present blocking slide gate from closing. WS end of pipe has been exposed so there is no way to stop water from flowing through pipe during highwater times. (DWR Sutter Yard - afreitag)6/23/2014 Same as last inspection. There is no way to stop water from flowing through pipe during high water times. (DWR Sutter Yard - afreitag)12/17/2013 Same as last inspection. (DWR Sutter Yard - afreitag)7/18/2013 Same as last inspection. (DWR Sutter Yard - afreitag)10/19/2012 Unauthorized 5 inch PVC pipe running through 36 inch crossing. 5 inch PVC crossing prevents slide gate from closing during high water. Debris and sediment inside riser. This crossing was listed in the USACE Periodic Inspection as ID# USACE\_CESPK\_MA1C\_2010\_p\_0258 for 5 inch PVC pipe running through culvert. (DWR UCIP - omagana) FIELD\_STRUCT\_DESC: 36-inch steel (not corrugated metal, as referenced in O&M manual) drainage pipe through the levee, approximately 14-16 feet below levee crown. Slide gate in corrugated metal pipe (CMP) riser on the waterside (WS) slope. Pipe also visible on the landside (LS). [Additional Reference(s): DWR Levee Log, 1992. USACE Sacramento O&M Manual 137, August 1955, (Station 331+31)]. FS Date: 10/1/2018 2:59:44 PM

View of levee crown at crossing.

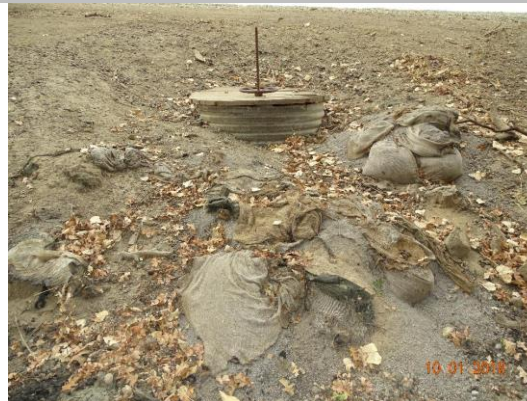
Photo 2 of 3 : UCIP\_SP\_2019\_53049\_78243.jpg

FS\_ID:53049  
DS\_ID:16446  
EP\_NO: N/A  
Repair Type: Urgent  
Crossing Status: Found  
UCIP Comments: 10/1/2018 PVC pipe underneath the slide gate that is located inside CMP riser on WS shoulder was restored and blocks gate from closing. Sediment built up at the bottom of CMP riser. PVC pipe needs to be removed in order to properly close slide gate. (O.Yakimov - DWR)5/3/2017 Pipe leaked during the Jan/Feb 2017 high water event. Sand bags were placed at both the LS and WS outlets as well as down inside the standpipe to slow the water flow. The 5inch pvc was cut away but the slide gate could still not close fully. Suspect sediment build up was in the bottom of the stand pipe was blocking the gate. Inside of pipe should be cleaned out. (DWR Sutter Yard-AFreitag)10/24/2016 Pvc was back running through the crossing and blocking the screwgate. photo attached(DWR Sutter Yard-AFreitag)9/28/2016 Crossing has been downgraded from Urgent to Non-Urgent 5-inch PVC pipe was cut to allow the slide gate to close. Need to contact owner to remove unauthorized pipe to comply with Title 23. (DWR UCIP - omagana)4/25/2016 5 inch pvc pipe running through crossing has been cut out to allow the slide gate to close. (DWR Sutter Yard - afreitag)4/20/2015 5inch pvc is still present blocking slide gate from closing. WS end of pipe has been exposed so there is no way to stop water from flowing through pipe during highwater times. (DWR Sutter Yard - afreitag)6/23/2014 Same as last inspection. There is no way to stop water from flowing through pipe during high water times. (DWR Sutter Yard - afreitag)12/17/2013 Same as last inspection. (DWR Sutter Yard - afreitag)7/18/2013 Same as last inspection. (DWR Sutter Yard - afreitag)10/19/2012 Unauthorized 5 inch PVC pipe running through 36 inch crossing. 5 inch PVC crossing prevents slide gate from closing during high water. Debris and sediment inside riser. This crossing was listed in the USACE Periodic Inspection as ID# USACE\_CESPK\_MA1C\_2010\_p\_0258 for 5 inch PVC pipe running through culvert. (DWR UCIP - omagana) FIELD\_STRUCT\_DESC: 36-inch steel (not corrugated metal, as referenced in O&M manual) drainage pipe through the levee, approximately 14-16 feet below levee crown. Slide gate in corrugated metal pipe (CMP) riser on the waterside (WS) slope. Pipe also visible on the landside (LS). [Additional Reference(s): DWR Levee Log, 1992. USACE Sacramento O&M Manual 137, August 1955, (Station 331+31)]. FS Date: 10/1/2018 2:59:44 PM

View of CMP riser at WS shoulder.

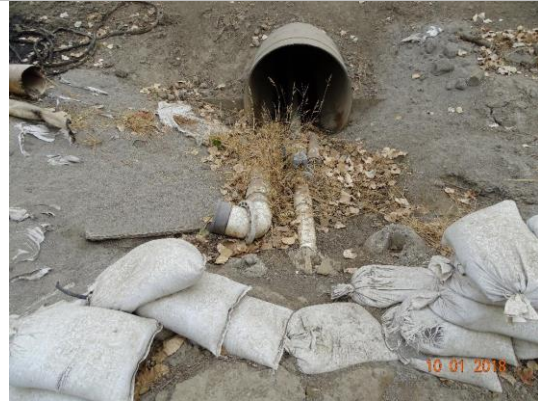
Photo 3 of 3 : UCIP\_SP\_2019\_53049\_78244.jpg

FS\_ID:53049  
DS\_ID:16446  
EP\_NO: N/A  
Repair Type: Urgent  
Crossing Status: Found  
UCIP Comments: 10/1/2018 PVC pipe underneath the slide gate that is located inside CMP riser on WS shoulder was restored and blocks gate from closing. Sediment built up at the bottom of CMP riser. PVC pipe needs to be removed in order to properly close slide gate. (O.Yakimov - DWR)5/3/2017 Pipe leaked during the Jan/Feb 2017 high water event. Sand bags were placed at both the LS and WS outlets as well as down inside the standpipe to slow the water flow. The 5inch pvc was cut away but the slide gate could still not close fully. Suspect sediment build up was in the bottom of the stand pipe was blocking the gate. Inside of pipe should be cleaned out. (DWR Sutter Yard-AFreitag)10/24/2016 Pvc was back running through the crossing and blocking the screwgate. photo attached(DWR Sutter Yard-AFreitag)9/28/2016 Crossing has been downgraded from Urgent to Non-Urgent 5-inch PVC pipe was cut to allow the slide gate to close. Need to contact owner to remove unauthorized pipe to comply with Title 23. (DWR UCIP - omagana)4/25/2016 5 inch pvc pipe running through crossing has been cut out to allow the slide gate to close. (DWR Sutter Yard - afreitag)4/20/2015 5inch pvc is still present blocking slide gate from closing. WS end of pipe has been exposed so there is no way to stop water from flowing through pipe during highwater times. (DWR Sutter Yard - afreitag)6/23/2014 Same as last inspection. There is no way to stop water from flowing through pipe during high water times. (DWR Sutter Yard - afreitag)12/17/2013 Same as last inspection. (DWR Sutter Yard - afreitag)7/18/2013 Same as last inspection. (DWR Sutter Yard - afreitag)10/19/2012 Unauthorized 5 inch PVC pipe running through 36 inch crossing. 5 inch PVC crossing prevents slide gate from closing during high water. Debris and sediment inside riser. This crossing was listed in the USACE Periodic Inspection as ID# USACE\_CESPK\_MA1C\_2010\_p\_0258 for 5 inch PVC pipe running through culvert. (DWR UCIP - omagana) FIELD\_STRUCT\_DESC: 36-inch steel (not corrugated metal, as referenced in O&M manual) drainage pipe through the levee, approximately 14-16 feet below levee crown. Slide gate in corrugated metal pipe (CMP) riser on the waterside (WS) slope. Pipe also visible on the landside (LS). [Additional Reference(s): DWR Levee Log, 1992. USACE Sacramento O&M Manual 137, August 1955, (Station 331+31)]. FS Date: 10/1/2018 2:59:44 PM

Pipe at LS toe.

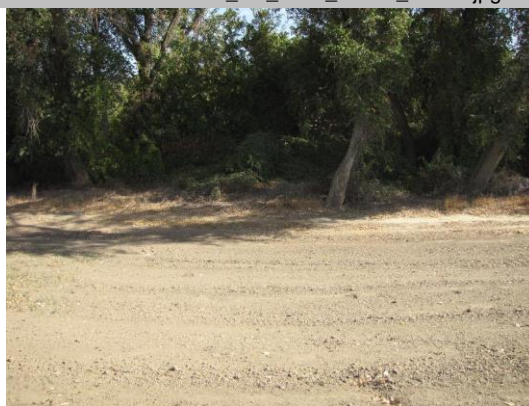
Photo 1 of 3 : UCIP\_SP\_2019\_51874\_70181.jpg

FS\_ID:51874  
DS\_ID:16425  
EP\_NO: N/A  
Repair Type: Non-Urgent  
Crossing Status: Found  
UCIP Comments: 5/3/2017 Abandoned- needs to be done properly.  
(DWR Sutter Yard- A Freitag)10/24/2016 Abandoned(DWR Sutter Yard- A Freitag)4/25/2016 Abandoned crossing.4/20/2015 Same as last inspection.6/23/2014 Same as last inspection.12/17/2013 Same as last inspection.7/18/2013 Same as last inspection.10/19/2012 Need to be properly abandoned concrete structure; plate covers concrete box; Concrete headwall damaged. This crossing was listed in the USACE Periodic Inspection as ID# USACE\_CESPK\_MA1C\_2010\_p\_0262 for damage to concrete structure (vertical 2 inch wide cracks and spalling visible).  
FIELD\_STRUCT\_DESC: \*ABANDONED\* 72-inch corrugated metal (precast concrete) drainage pipe through the levee at an unknown depth below the crown. Structure is blocked on the waterside (WS) end with 3-foot concrete plug installed in 1980. Slide gate in concrete well on the landside (LS) shoulder. Concrete headwall at both toes. WS headwall not found. [Additional Reference(s): DWR Levee Log, 1992. USACE Sacramento O&M Manual 137, August 1955, (Station 339+74)].

View of WS no structure features visible.

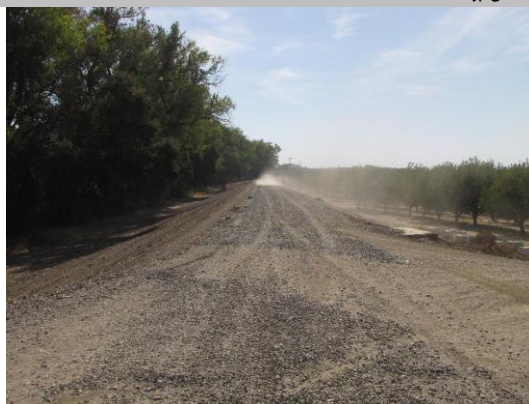
Photo 2 of 3 : UCIP\_SP\_2019\_51874\_70180.jpg

Overview of levee crown looking downstream at crossing.

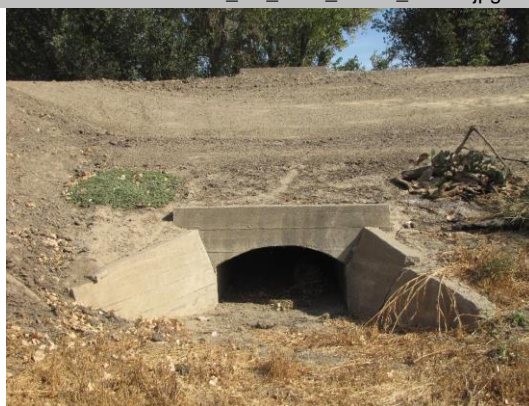
Photo 3 of 3 : UCIP\_SP\_2019\_51874\_70179.jpg

Comment Code						
Inspector Comment						
FS_ID:51874 DS_ID:16425 EP_NO: N/A Repair Type: Non-Urgent Crossing Status: Found UCIP Comments: 5/3/2017 Abandoned- needs to be done properly. (DWR Sutter Yard- A Freitag)10/24/2016 Abandoned(DWR Sutter Yard- A Freitag)4/25/2016 Abandoned crossing.4/20/2015 Same as last inspection.6/23/2014 Same as last inspection.12/17/2013 Same as last inspection.7/18/2013 Same as last inspection.10/19/2012 Need to be properly abandoned concrete structure; plate covers concrete box; Concrete headwall damaged. This crossing was listed in the USACE Periodic Inspection as ID# USACE_CESPK_MA1C_2010_p_0262 for damage to concrete structure (vertical 2 inch wide cracks and spalling visible). FIELD_STRUCT_DESC: *ABANDONED* 72-inch corrugated metal (precast concrete) drainage pipe through the levee at an unknown depth below the crown. Structure is blocked on the waterside (WS) end with 3-foot concrete plug installed in 1980. Slide gate in concrete well on the landside (LS) shoulder. Concrete headwall at both toes. WS headwall not found. [Additional Reference(s): DWR Levee Log, 1992. USACE Sacramento O&M Manual 137, August 1955, (Station 339+74)]. FS Date: 5/23/2017 10:13:24 AM

View of structure located in LS.

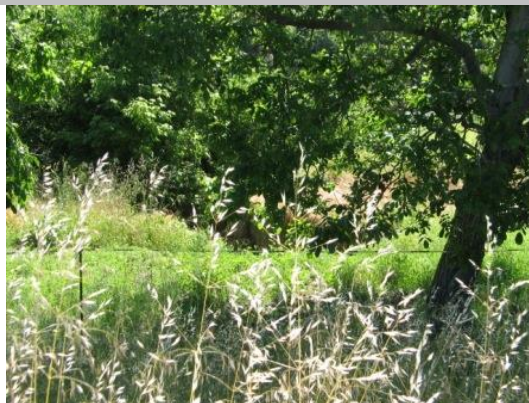
Photo 1 of 1 : SP\_2019\_MA0001\_297\_18\_20190327\_00008.jpg

View of the erosion along the waterside of the levee.

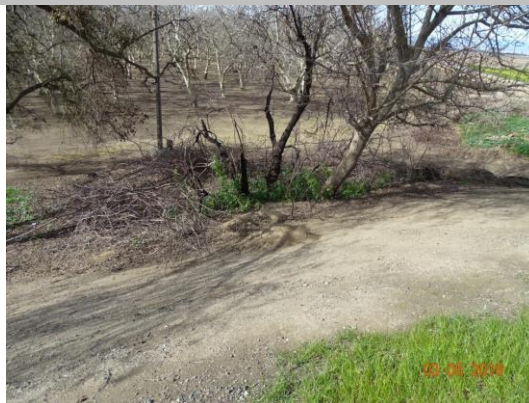
Photo 1 of 1 : SP\_2019\_MA0001\_297\_69\_20190327\_00016.jpg

View of the rodent holes along the landside slope.

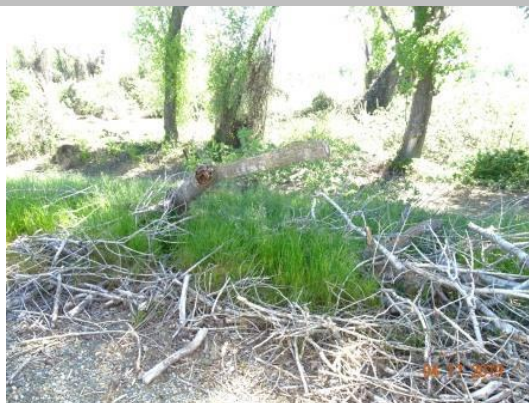
Photo 1 of 1 : SP\_2019\_MA0001\_297\_116\_20190418\_00155.jpg

LM Start	11.51	Rating **	U	Issue No.	116
LM End	11.51	Issue Type +	Ma	Location *	WS
Category	Earthen Levee			GPS Latitude/Longitude	
				Start	End
Item	Encroachments			39.347841 °	39.347841 °
				-122.031342 °	-122.031342 °
DWR ID	DWR_MA0001_01_s _ 2019_116				
Comment Code					
TR : Tree or limb					
Inspector Comment					
The fallen tree should be removed from the waterside slope.

View of the fallen tree on the waterside slope. Spring 2019.

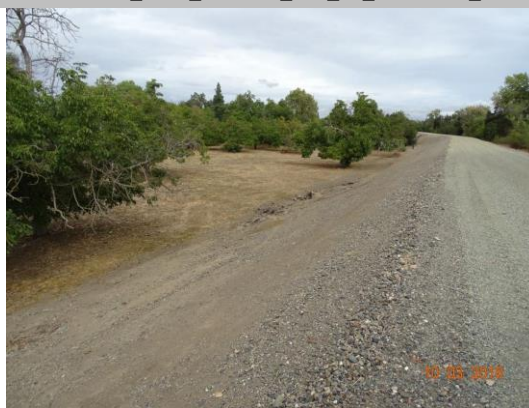
Photo 1 of 1 : SP\_2019\_MA0001\_297\_71\_20190327\_00017.jpg

View of the rodent holes along the landside slope.

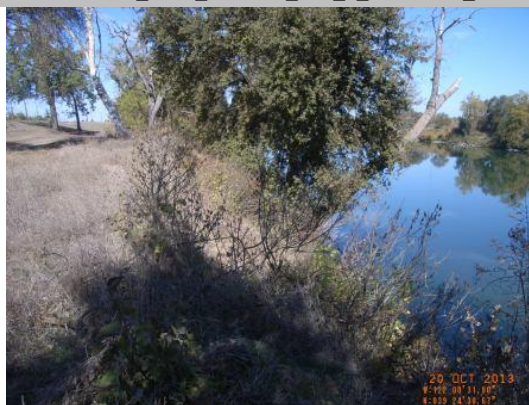
Photo 1 of 2 : SP\_2019\_MA0001\_297\_9\_20190327\_00005.jpg

LM Start	16.35	Rating **	A/W	Issue No.	9
LM End	16.58	Issue Type +	Ma	Location *	WS
Category	Supplemental			GPS Latitude/Longitude	
				Start	End
Item	2017 USACE Erosion Survey, DRAFT			39.407837 °	39.411111 °
				-122.008763 °	-122.009238 °
DWR ID	DWR_ST0010_02_f_2022_7				
Comment Code					
Inspector Comment					
2017 Site ID: SAC 164.3 R					
Status: Eroding					
2017 Field Notes: New erosion along entire site.					
Site History: Erosion site added in 1997 and removed in 2005. 2009 -					
Site added back in, hard toe with slow moving erosion. Potential					
geotechnical failure. 2011 - Site extended downstream.
